**Flood Control Project Maintenance
Levee Inspections**

Maintenance Issue Types Only, Levee Inspection Report By Mile - Spring 2017

Sutter Maintenance Yard Maintenance Area 0001

Waterway	Bank	Unit Miles	Inspection Start/End	Inspector
Unit No. 01 Sacramento River	Right	16.76	03/24/2017 03/24/2017	Bob Duffey

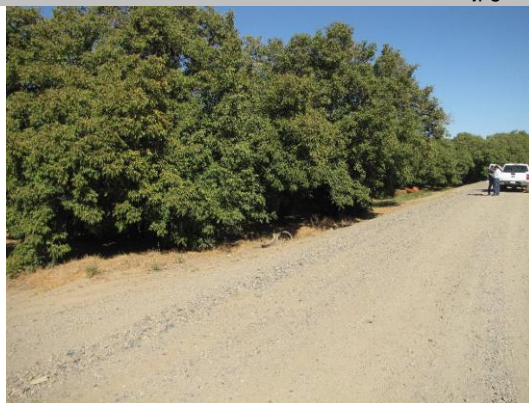
Photo 3 of 3 : UCIP_SP_2017_51852_70062.jpg

View of LS looking upstream at crossing.

FS_ID:51852
 DS_ID:16430
 EP_NO: 9487
 Repair Type: Non-Urgent
 Crossing Status: Found
 UCIP Comments: 5/3/2017 WS end still partially plugged. (DWR Sutter Yard- A Freitag) 10/24/2016 WS end is still partially plugged. (DWR Sutter Yard- A Freitag) 4/25/2016 WS pipe end is still plugged with soil. Rest of the pipe appeared to be in good condition. 4/20/2015 WS pipe end is plugged about 50% by soil. 6/18/2014 Same as last inspection. 12/17/2013 Same as last inspection. 7/18/2013 WS pipe end has been reformed but is still clogged about 50% by sediment. 10/18/2012 Remove dirt and debris in riser. Outlet deformed and blocked over 50%. Debris-round concrete section on landward side. This crossing was listed in the USACE Periodic Inspections as ID# USACE_CESPK_MA1C_2010_p_0116 for crossing outlet deformed and clogged with dirt.
 FIELD_STRUCT_DESC: 1 of 2: 36-inch corrugated metal drainage pipe through the levee, approximately 12-15 feet below the crown. Slide gates in corrugated metal pipe (CMP) riser located on the waterside (WS) slope. Pipe daylights on the landside (LS). (Automatic Board Order (ABO) issued as Permit No. 9487, 1974 - Jimeno Rancho)

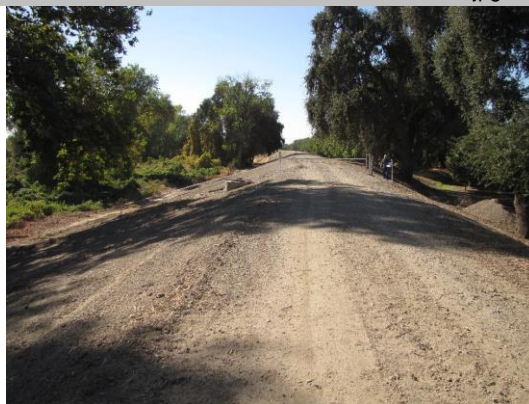
Photo 1 of 3 : UCIP_SP_2017_51854_70078.jpg

FS_ID:51854
DS_ID:16429
EP_NO: 9472
Repair Type: Non-Urgent
Crossing Status: Found
UCIP Comments: 5/3/2017 LS inlet partially plugged with soil. Some debris still present inside riser. (DWR Sutter Yard-AFreitag)10/24/2016 Debris still inside of riser.(DWR Sutter Yard-AFreitag)4/25/2016 Pipe still inside of riser and LS end plugged about 50% by soil.4/20/2015 Same as last inspection.6/18/2014 Same as last inspection.12/17/2013 Same as last inspection.7/18/2013 Same as last inspection.10/18/12 Remove debris from riser. Landward inlet is blocked by over 50%. This crossing was listed in the USACE Periodic Inspections as ID# USACE_CESPK_MA1C_2010_p_0128 for sediment build up at inlet (landward side) and debris inside riser. FIELD_STRUCT_DESC: 54-inch corrugated metal drainage pipe through the levee, approximately 12-15 feet below the crown. Slide gate in corrugated metal pipe (CMP) riser on the waterside (WS) slope. 48-inch CMP at landside (LS) slope. This crossing crosses the levee at an angle. (Automatic Board Order (ABO) issued as Permit No. 9472, 1974 - Ballard)) [Additional Reference(s): DWR Levee Log, 1992. USACE Sacramento O&M Manual 137, August 1955, (Station 120+00)]. FS Date: 5/19/2017 1:23:34 PM

View of levee crown looking downstream at crossing. CMP riser located on WS shoulder.

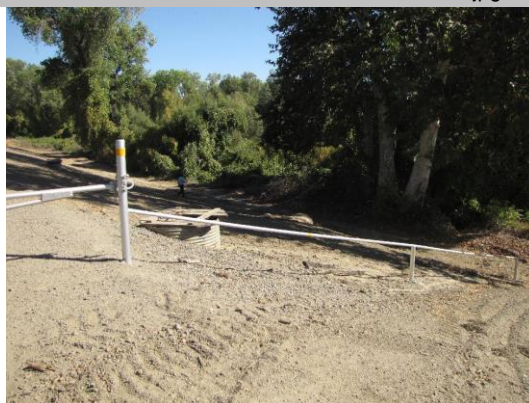
Photo 2 of 3 : UCIP_SP_2017_51854_70079.jpg

View of WS looking up slope and channel.

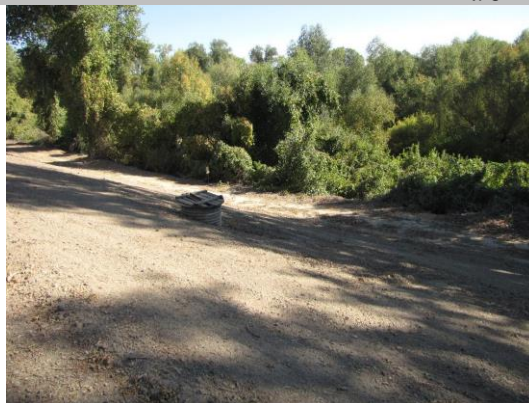
Photo 2 of 3 : UCIP_SP_2017_51855_70084.jpg

FS_ID:51855
DS_ID:16428
EP_NO: 9467
Repair Type: Non-Urgent
Crossing Status: Found
UCIP Comments: 5/3/2017 Abandoned- needs to be done so properly. (DWR Sutter Yard- A Freitag)10/24/2016 Abandoned.(DWR Sutter Yard- A Freitag)4/25/2016 Abandoned crossing. Unable to locate any WS and LS pipe ends.4/20/2015 Same as last inspection.6/18/2014 Same as last inspection.12/17/2013 Same as last inspection.7/18/2013 Same as last inspection.10/18/2012 Only riser visible. Debris and sediment blocking gate. Gate inside riser is buried and non-functional. If crossing is abandoned, owner needs to properly abandon. This crossing was listed in the USACE Periodic Inspections as ID# USACE_CESPK_MA1C_2010_p_0132 no culvert through the levee is visible here.
FIELD_STRUCT_DESC: *ABANDONED* 24-inch corrugated metal drainage pipe through the levee, approximately 12-15 feet below the crown. Slide gate in CM pipe riser on the waterside (WS) slope. No signs of inlet visible on the landside (LS). (Automatic Board Order (ABO) issued as Permit No. 9467, 1974 - Lovell E. Spurgeon)

View of WS slope and toe.

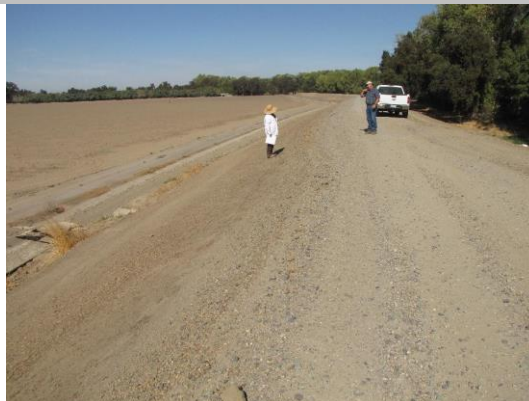
Photo 1 of 3 : UCIP_SP_2017_51859_70110.jpg

FIELD_STRUCT_DESC: 36-inch corrugated metal drainage pipe through the levee, approximately 12-15 feet below the crown. Slide gate in corrugated metal pipe (CMP) riser on the waterside (WS) slope. (Permit No. 9490, 1955 - Charles & Virginia Yerxa) [Additional Reference(s): DWR Levee Log, 1992. USACE Sacramento O&M Manual 137, August 1955, (Station 177+67)].
FS Date: 5/19/2017 1:53:31 PM

View of LS looking upstream.

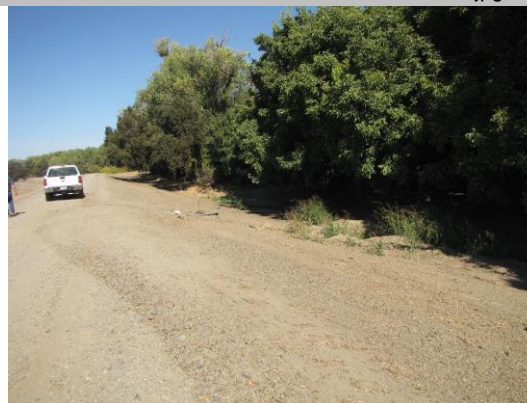
Photo 2 of 3 : UCIP_SP_2017_51859_70109.jpg

View of WS looking upstream.

Comment Code					
Inspector Comment					
<p>FS_ID:51859 DS_ID:16426 EP_NO: 9490 Repair Type: Non-Urgent Crossing Status: Found UCIP Comments: 5/3/2017 Sediment build up in WS pipe end. WS slide gate stem bent but it does not affect its operation. (DWR Sutter Yard- A Freitag)10/24/2016 WS slide gate stem is still bent.(DWR Sutter Yard- A Freitag)4/25/2016 WS slide gate is slightly bent. Rest of crossing appears to be in good condition. 4/20/2015 LS inlet still has some minor sediment build up. Needs to be cleaned.6/18/2014 Same as last inspection.12/17/2013 Same as last inspection.7/18/2013 WS slide gate looks to be in good condition but stem is slightly bent. Not sure if bend will hinder gates operation or not. LS inlet is still blocked by minor sediment build up.10/18/2012 LS pipe slightly deformed and sediment build up blocking about 30% of opening; need to check the condition of the slide gate-need photo. Metal marker down. This crossing was listed in the USACE Periodic Inspection as ID# USACE_CESPK_MA1C_2010_p_0187 for sediment build up at landward toe. FIELD_STRUCT_DESC: 36-inch corrugated metal drainage pipe through the levee, approximately 12-15 feet below the crown. Slide gate in corrugated metal pipe (CMP) riser on the waterside (WS) slope. (Permit No. 9490, 1955 - Charles & Virginia Yerxa) [Additional Reference(s): DWR Levee Log, 1992. USACE Sacramento O&M Manual 137, August 1955, (Station 177+67)]. FS Date: 5/19/2017 1:53:31 PM</p>

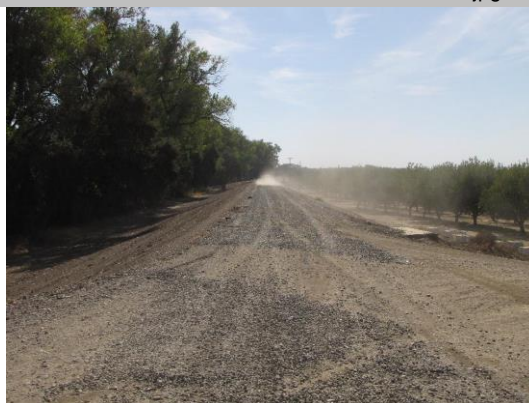
Photo 2 of 3 : UCIP_SP_2017_51874_70180.jpg

Overview of levee crown looking downstream at crossing.
